## Test Report

No.: SDHL1701000444FT

Sample Description : OFFICE CHAIR  
Buyer Item No. : DC-10  
Sample Receiving Date : Jan.10, 2017  
Test Performing Date : Jan.10, 2017 to Jan.12, 2017

Test(s) Requested	Result(s)
Clause 6, 7 & 8 of ANSI/BIFMA X5.1:2011 (Type II)	PASS

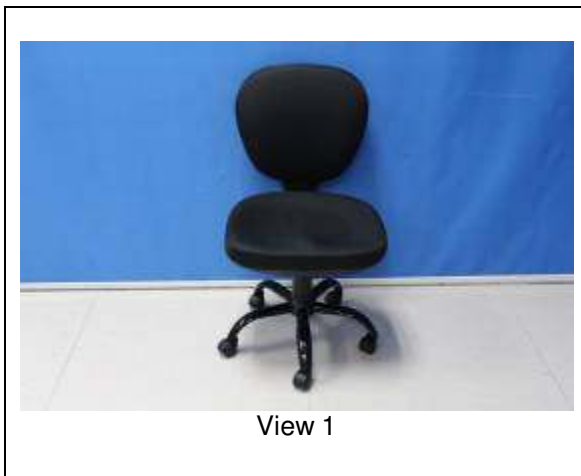
View 1

#### Sample as Received

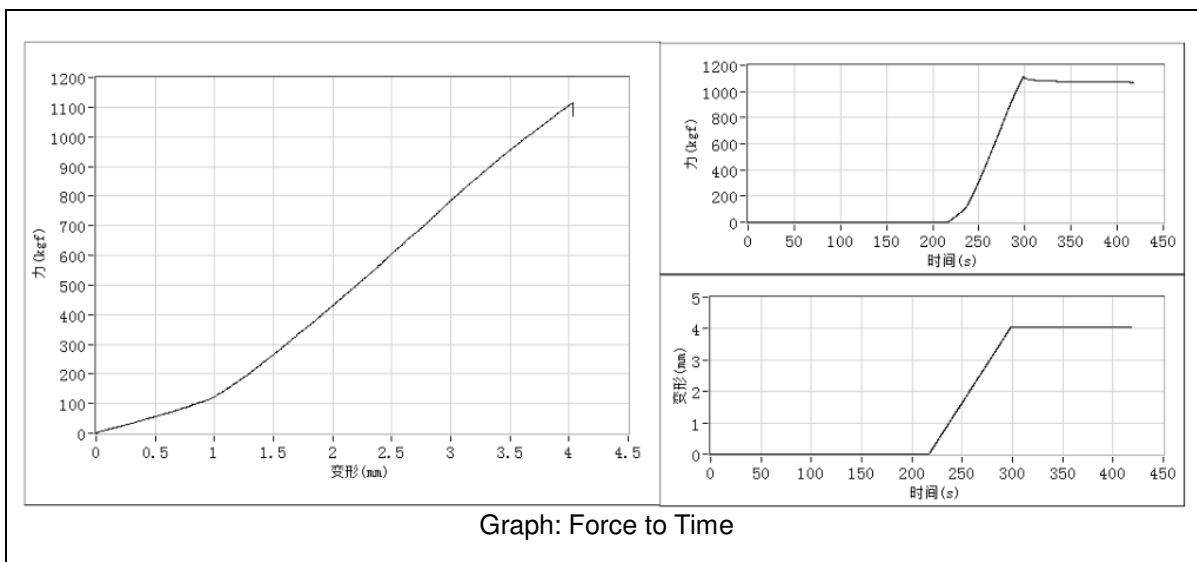
**Test Pictures with Details**

Test and Requirements	Test Results
<b>6 Backrest Strength Test - Static - Type II &amp; III</b>	
<b>6.4.1 Functional Load</b> There shall be no loss of serviceability to the chair when 667 N (150 lbf.) is applied to the backrest at the specified position for one (1) minute. With the backrest at its back stop position, apply a force that is initially 90 degrees ± 10 degrees to the plane of the backrest. The force is not intended to be maintained at 90 degrees ± 10 degrees throughout the loading of the backrest.	PASS
<b>6.4.2 Proof Load</b> There shall be no sudden and major change in the structural integrity of the chair, loss of serviceability is acceptable, when 1112 N (250 lbf.) is applied to the backrest at the specified position for one (1) minute. With the backrest at its back stop position, apply a force that is initially 90 degrees ± 10 degrees to the plane of the backrest. The force is not intended to be maintained at 90 degrees ± 10 degrees throughout the loading of the backrest.	PASS

<b>7 Base Test – Static</b> There shall be no sudden and major change in the structural integrity of the base. The center column may not touch the test platform during the load applications when a force of 11,120 N (2500 lbf.) is applied to the vertical support column, or test fixture that simulates the taper/base interface for one (1) minute. Remove the force, and then apply a second force of 11,120 N (2500 lbf.) for one (1) minute.	PASS
<b>8 Drop Test - Dynamic</b>	
<b>8.4.1 Functional Load Test</b> There shall be no loss of serviceability when a test bag weighing 102 kg (225 lb.) is free fell from 152 mm (6 in.) above the uncompressed seat to the specified position on seat. Remove the bag, and set height to its lowest position and repeat the test for chairs with seat height adjustment features.	PASS
<b>8.4.2 Proof Load Test</b> There shall be no sudden and major change in the structural integrity of the chair. Loss of serviceability is acceptable when a test bag weighing 136 kg (300 lb.) is free fell from 152 mm (6 in.) above the uncompressed seat to the specified position on seat. Remove the bag, and set height to its lowest position and repeat the test for chairs with seat height adjustment features.	PASS
