Test Report

No.: SDHL1701000447FT

Sample Description : OFFICE CHAIR
Buyer Item No. : DC-107
Sample Receiving Date : Jan.10, 2017
Test Performing Date : Jan.10, 2017 to Jan.12, 2017

Test(s) Requested	Result(s)
Clause 6, 7 & 8 of ANSI/BIFMA X5.1:2011 (Type I, III)	PASS

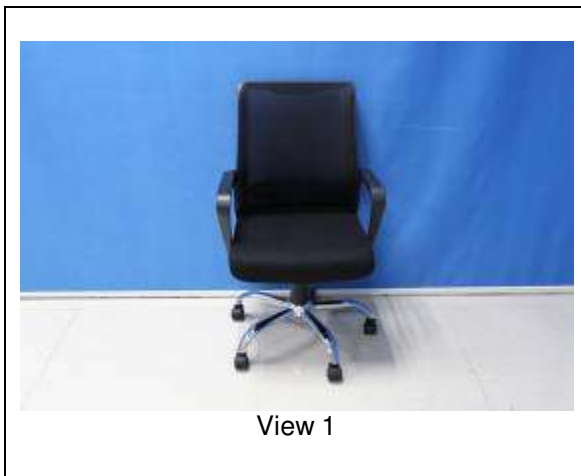
View 1

Sample as Received

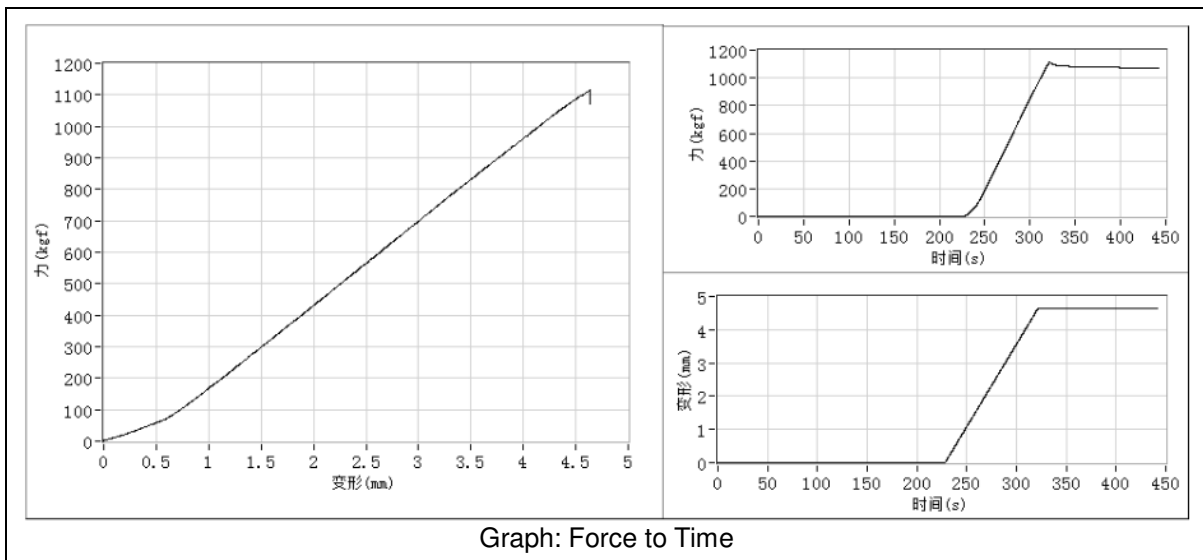
Test Pictures with Details

Test and Requirements	Test Results
6 Backrest Strength Test - Static - Type II & III	
6.4.1 Functional Load There shall be no loss of serviceability to the chair when 667 N (150 lbf.) is applied to the backrest at the specified position for one (1) minute. With the backrest at its back stop position, apply a force that is initially 90 degrees ± 10 degrees to the plane of the backrest. The force is not intended to be maintained at 90 degrees ± 10 degrees throughout the loading of the backrest.	PASS

6.4.2 Proof Load There shall be no sudden and major change in the structural integrity of the chair, loss of serviceability is acceptable, when 1112 N (250 lbf.) is applied to the backrest at the specified position for one (1) minute. With the backrest at its back stop position, apply a force that is initially 90 degrees ± 10 degrees to the plane of the backrest. The force is not intended to be maintained at 90 degrees ± 10 degrees throughout the loading of the backrest.	PASS
7 Base Test – Static There shall be no sudden and major change in the structural integrity of the base. The center column may not touch the test platform during the load applications when a force of 11,120 N (2500 lbf.) is applied to the vertical support column, or test fixture that simulates the taper/base interface for one (1) minute. Remove the force, and then apply a second force of 11,120 N (2500 lbf.) for one (1) minute.	PASS

8 Drop Test - Dynamic	
8.4.1 Functional Load Test There shall be no loss of serviceability when a test bag weighing 102 kg (225 lb.) is free fell from 152 mm (6 in.) above the uncompressed seat to the specified position on seat. Remove the bag, and set height to its lowest position and repeat the test for chairs with seat height adjustment features.	PASS

8.4.2 Proof Load Test There shall be no sudden and major change in the structural integrity of the chair. Loss of serviceability is acceptable when a test bag weighing 136 kg (300 lb.) is free fell from 152 mm (6 in.) above the uncompressed seat to the specified position on seat. Remove the bag, and set height to its lowest position and repeat the test for chairs with seat height adjustment features.	PASS
